# Building To Resist The Effect Of Wind

NBS BUILDING SCIENCE SERIES 100-3

## VOLUME 3: A Guide for Improved Masonry and Timber Connections in Buildings

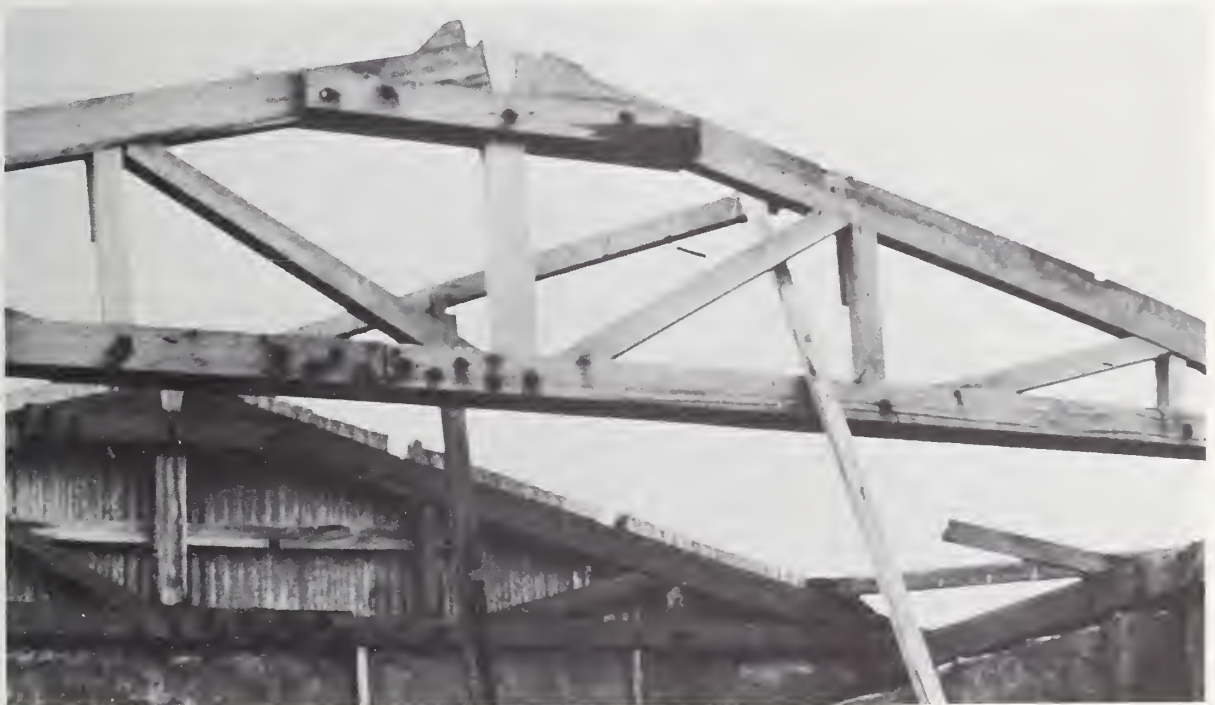
Figure 10 exhibits a typical failure of the fasteners connecting the purlins to the top chords of the trusses. Most of the roofing was "peeled off" in this manner. Portions of the corrugated iron roofing found on the ground contained the purlins with their metal wire attachments still in place (fig. 50). Instability of the trusses, few of which were still standing, was attributed to the loss of purlins and the absence of other longitudinal bracing between the trusses. The collapse of the masonry walls as shown in figure 8 was likewise attributed to the loss of lateral support at the roof level. However, the extent and severity of wall damage is also attributed to the absence of connections between abutting walls and the ineffectiveness of the vertical anchorage at the base. As indicated in figure 9, the only anchorage consisted of steel plates bolted to the wood posts. Close inspection revealed severe corrosion of these plates, especially at the ruptured section through the bolt-holes (fig. 9). The masonry walls in these buildings were nonload-bearing as they were stopped short of the roof to provide openings at the top (fig. 8). Thus the wood posts were the only vertical load-bearing elements and with the loss of the roof many of the corner posts were tipped over (fig. 8).

**FIGURE 10** ROOF FAILURE IN BUILDING CAUSED BY NOVEMBER 1974 TYPHOON IN  
THE PHILIPPINES.

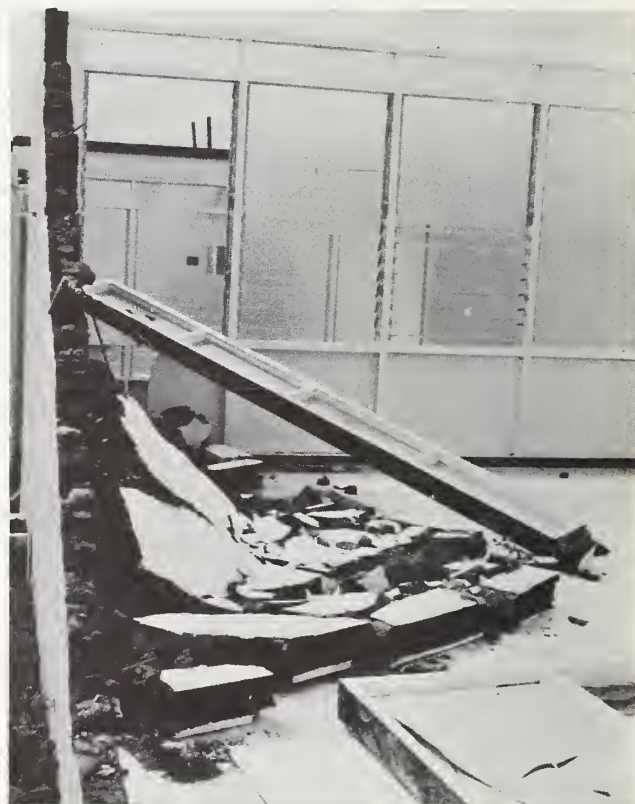
Figures 11 to 13 show single family housing units of concrete masonry bearing wall construction, located in Central Luzon, the Philippines, that were damaged or destroyed by the November, 1970 typhoon. An inherent weakness of these systems is the absence of peripheral support of the masonry walls at the top because of a local preference for large openings at these locations. This practice reduces the effectiveness of the roof to function as a diaphragm and makes it more susceptible to failure by wind suction or uplift. As indicated in figure 11, most of the roofs of these units were removed by the storm. Inspection of figures 12 and 13 indicates good quality workmanship was used in constructing the masonry walls which contained vertical reinforcement in grouted cores. Note that the nails between the top window frame insert and the wall below or the peripheral wood joist above were not effective in preventing the

**FIGURE 12** SINGLE FAMILY HOUSE SHOWING COLLAPSE OF ROOF AND EXTERIOR WALL DURING THE PHILLIPINES TYPHOON IN NOVEMBER 1970.

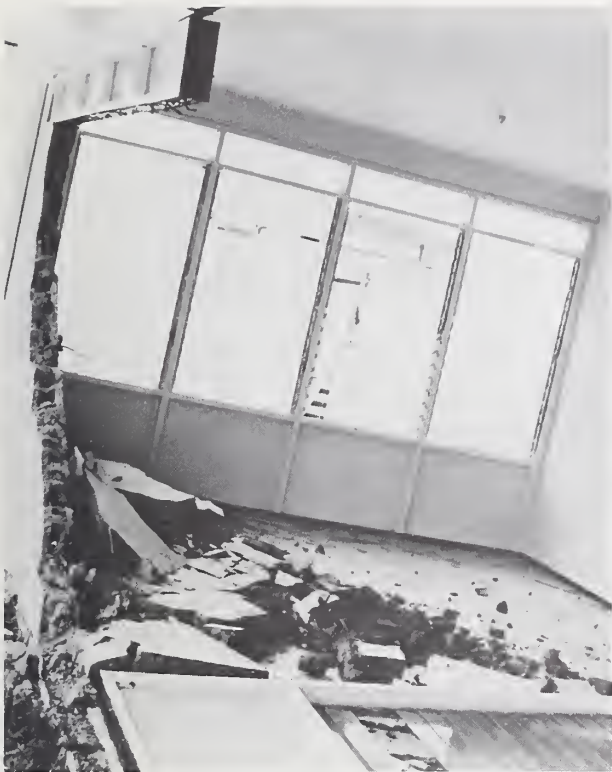
**FIGURE 13** INTERIOR DAMAGE OF SINGLE FAMILY HOUSE CAUSED BY THE NOVEMBER 1970 TYPHOON IN THE PHILIPPINES.

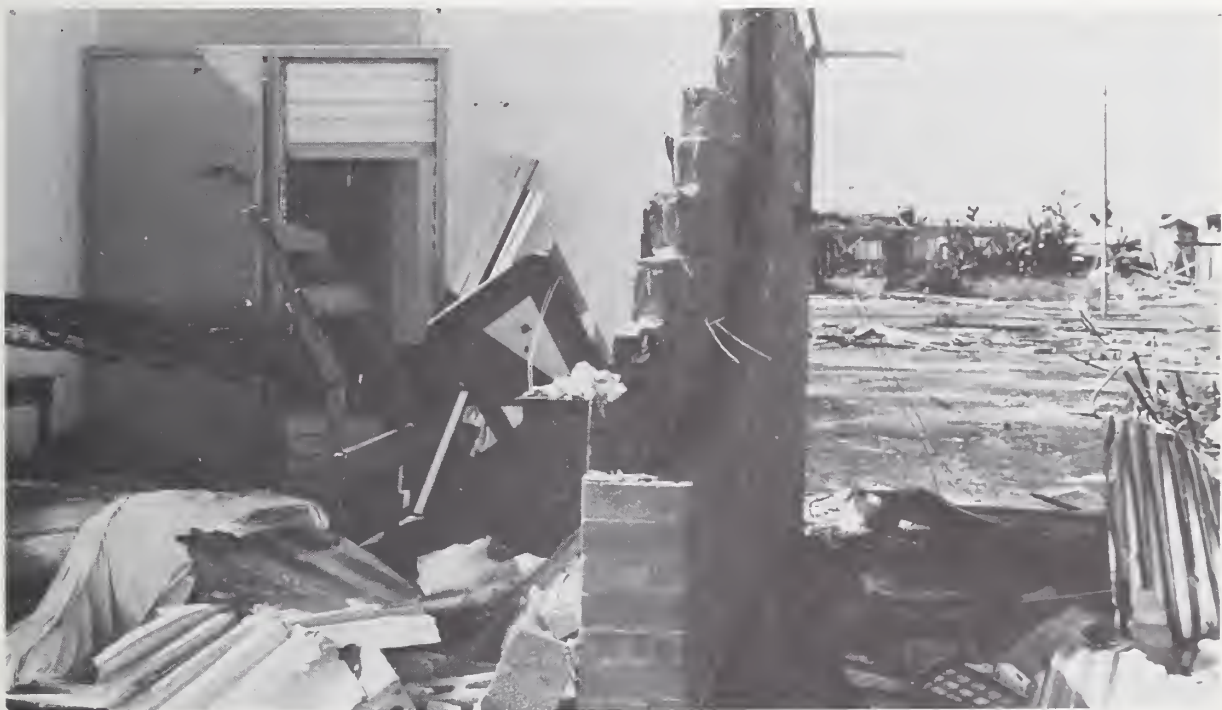
Figures 14 to 17 exhibit structures consisting of different types of masonry wall systems that sustained severe damage or were destroyed by the December 1974 cyclone in Darwin, Australia. These structures represented engineered masonry construction with respect to the quality of workmanship and adherence to Australian masonry codes and standards (which are comparable to those in the United States). The Darwin experience demonstrated that compliance with current standards does not necessarily produce a structure capable of resisting the estimated 65 m/s (150 mph) winds experienced during this storm. However, it does indicate the need to reexamine the existing provisions with the objective of developing improved design criteria, connection details, and construction practices in order to mitigate the extent of damage associated with extreme winds.

**FIGURE 14** RESIDENTIAL BUILDING IN DARWIN, AUSTRALIA, DESTROYED BY THE DECEMBER 1974 CYCLONE.

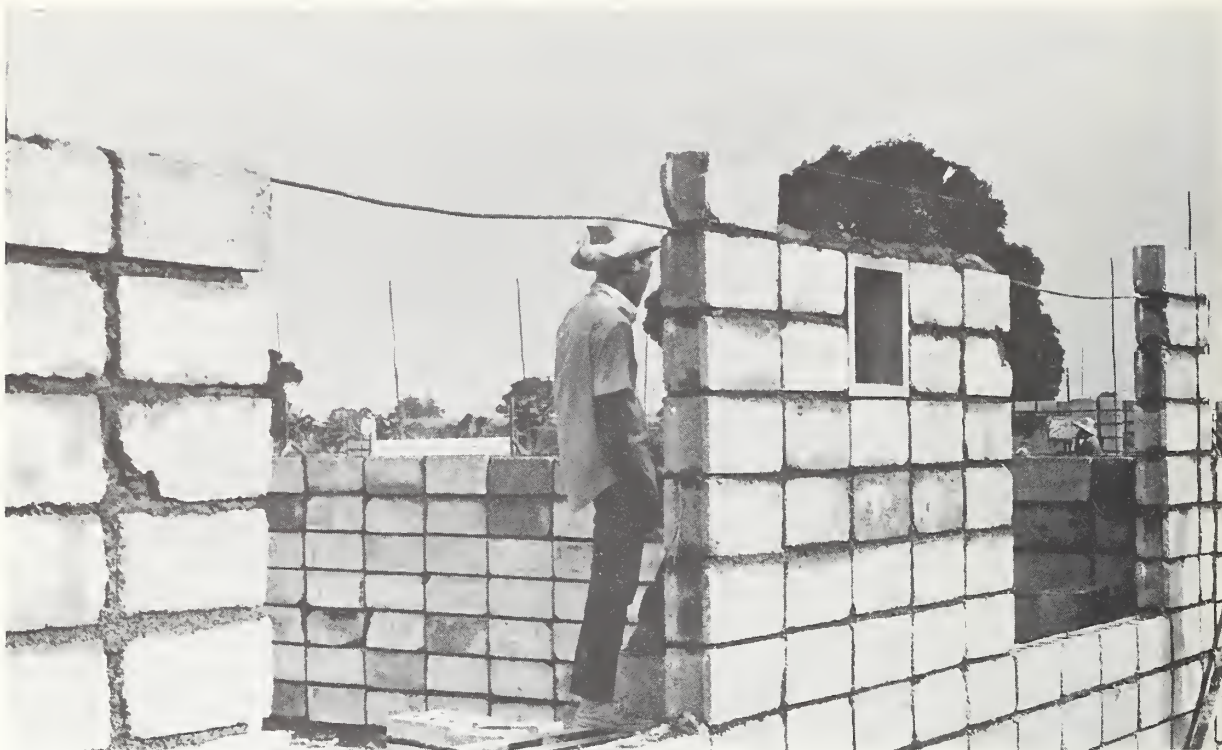
Figures 18 and 19 show two different stages of construction of a single family house located in Central Luzon, the Philippines. The walls are built with 3-core concrete block units (some of which may be seen lying on the ground in fig. 18). The units are laid in stacked bond to permit placement of reinforcement through the vertically aligned cores. On the basis of figure 19 the quality of masonry construction is deemed inferior by existing masonry standards. Some of the deficiencies noted are: (1) use of defective units, (2) partially filled and non-uniform mortar joints, (3) insufficient horizontal reinforcement for stacked bond construction, and (4) insufficient lintel reinforcement above the openings. It should be pointed out, however, that this system utilizes a peripheral concrete bond beam cast directly above the lintel course (see fig. 18). From the standpoint of overall structural integrity in a severe wind environment, attention is drawn to the practice of using large roof overhangs which are particularly susceptible to wind damage as they are subjected to a positive pressure from below and suction from above [2]. A potentially critical condition also exists in the masonry column supporting a larger overhang at the corner of the landing. Unless substantial top and bottom anchorage and vertical reinforcement is supplied in the column, which is not likely to be the case, given the limited available core space in the single unit section, there is a high probability that the column will fail under the impact of windborne missiles and/or uplift forces exerted by the roof in a severe windstorm.

**FIGURE 19** STACKED BOND CONCRETE MASONRY WALL CONSTRUCTION FOR SINGLE FAMILY OCCUPANCY IN CENTRAL LUZON, THE PHILIPPINES.

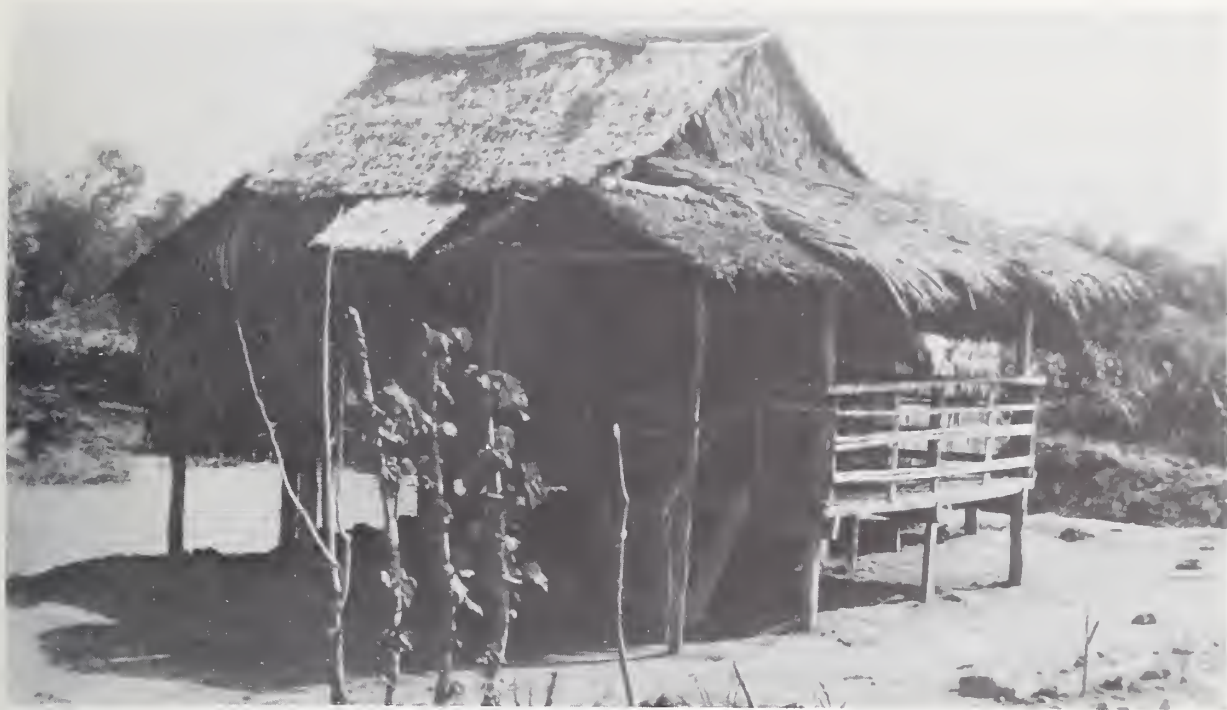
- (1) Pole-type construction in which poles are set into the ground to serve as foundation and extend to the roof (fig. 39).

FIGURE 39 POLE-TYPE CONSTRUCTION.

This type of construction is well suited to high wind areas because the major structural member, the pole, serves as the connecting link between all other structural members. If the poles are set 1.2 m (4 ft) or more into the ground, they serve as anchors for the building. For long life, all poles must be pressure treated for resistance to decay and insect attack.

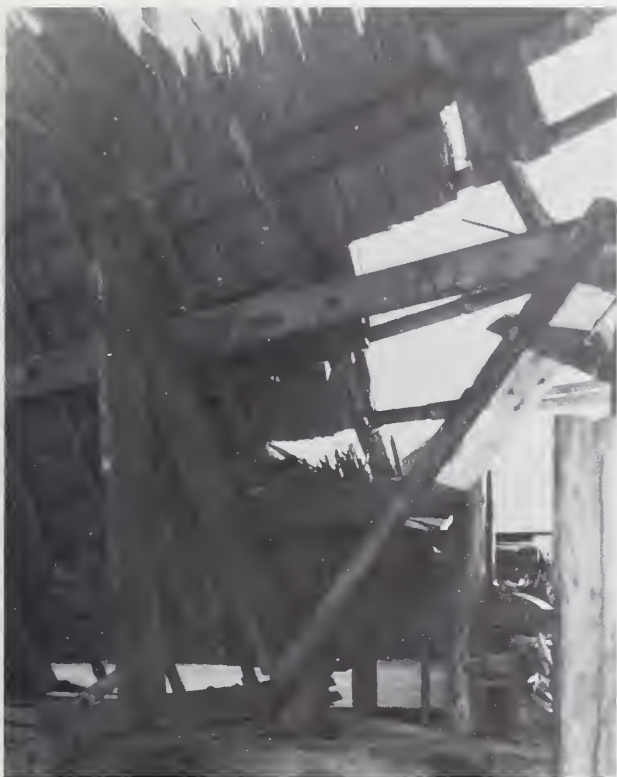
**FIGURE 43** THATCH ROOF WITH THATCH PARTIALLY BLOWN OFF.

Covering materials for this type of construction are often thatch roofs and walls of thatch or bamboo. There appears to be no way to assure anchorage of thatch during high winds (fig. 33). Wood siding nailed to framing members offers good resistance to wind, but nails should be corrosion resistant.

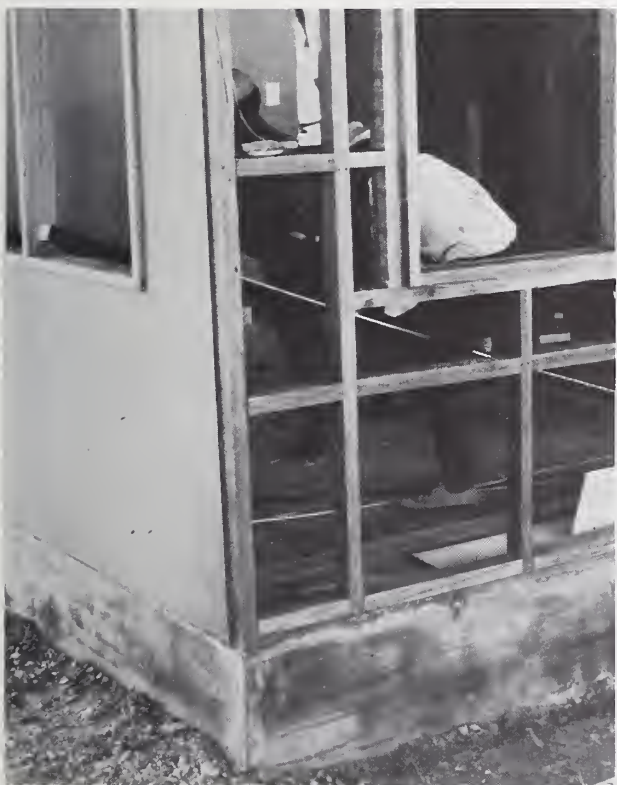
Covering material applied on the outside of the framing (fig. 44) protects the wall framing and connectors from rain. Walls with the covering set into the framing have a greater potential for trapping water, and thus promoting decay. Anchor bolts on the outside of the wall are particularly susceptible to trapping water (fig. 45). They can easily be placed on the inside for protection. The type of sill plate shown in figure 45 also traps water. The sill plate should at least be sloped to the outside so water will drain from it, and the joint with panel materials should be caulked.

**FIGURE 44** COVERING MATERIAL ON THE OUTSIDE PROTECTS FRAMING AND CONNECTORS.
